**Allana
Buick
Bers**

Kona Community Hospital Building Envelope Assessment

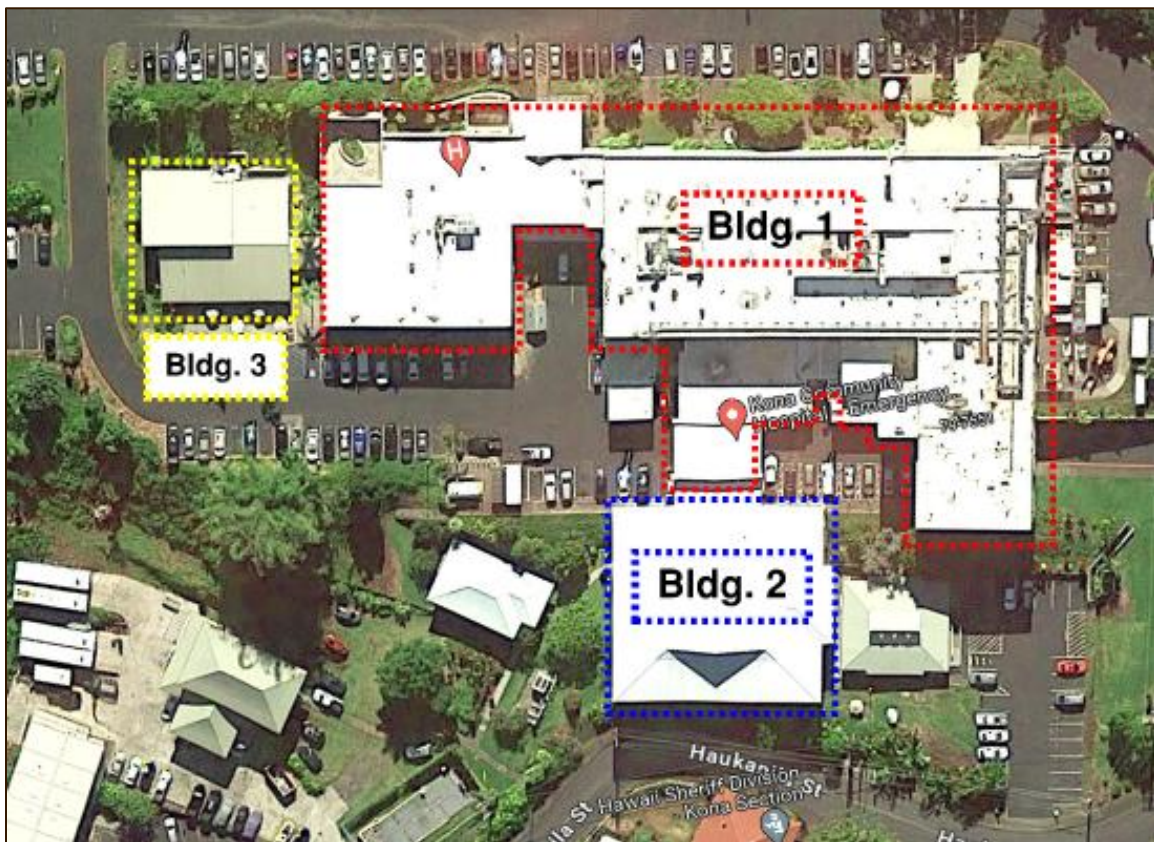
Figure 1 - Aerial image of Kona Community Hospital with subject building outlined and labeled

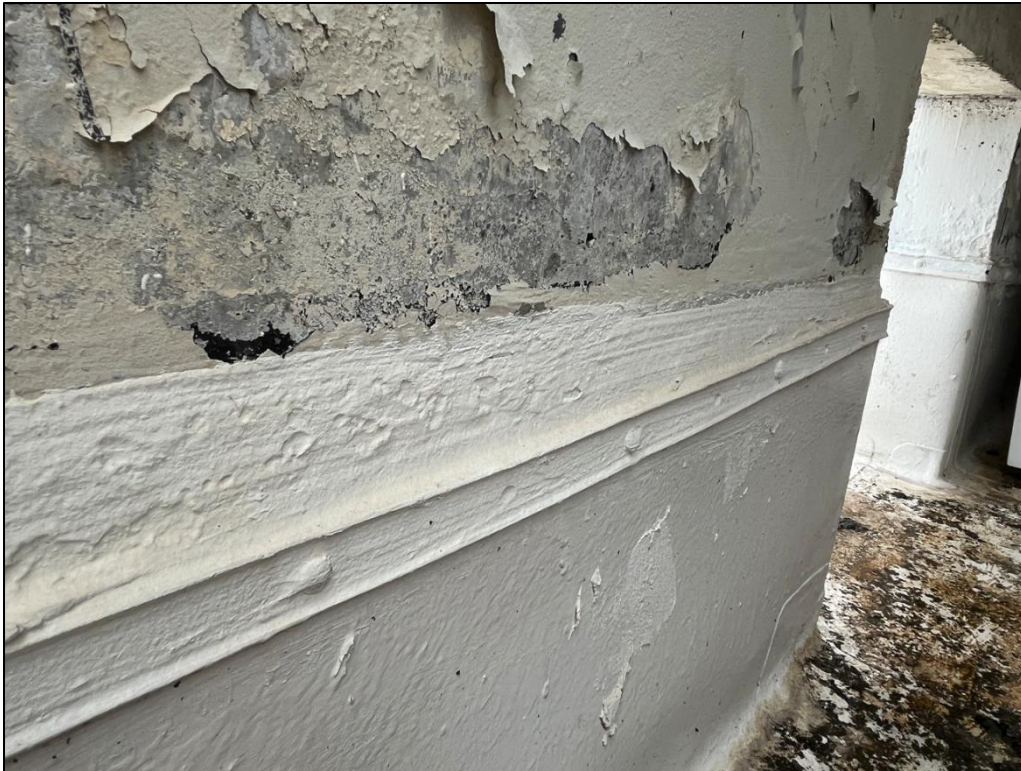
Photo 3 - Typical TPO membrane roof base flashing termination with fluid applied flashing repairs

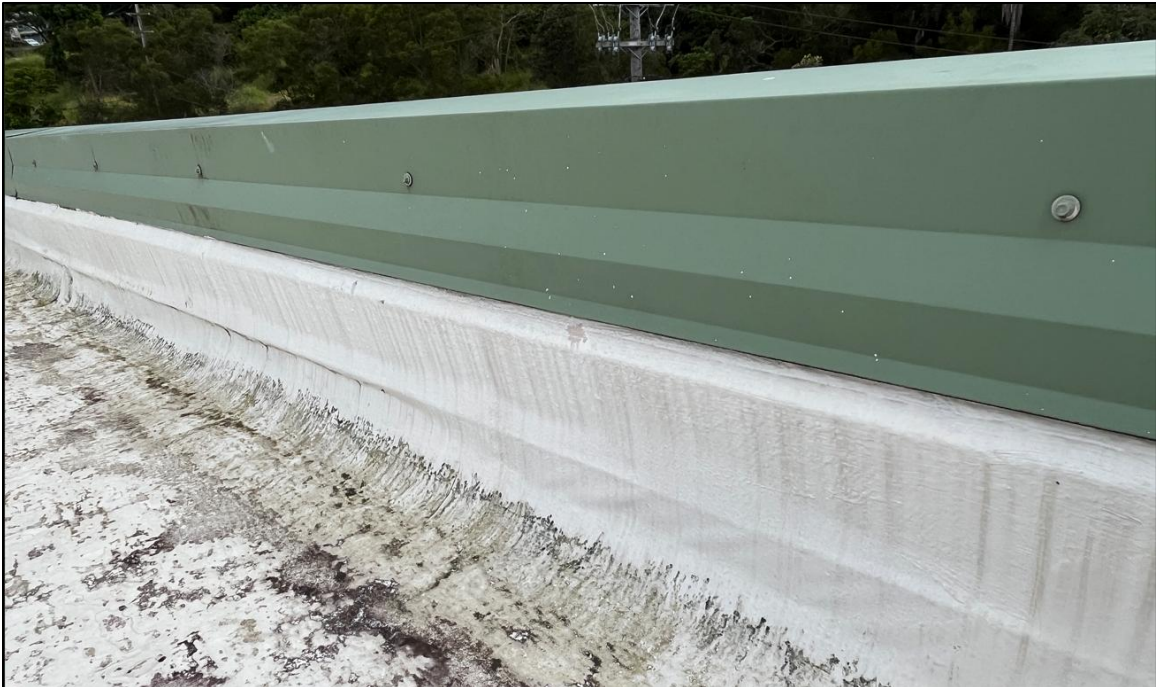
Photo 4 - Sheet metal coping over parapet wall and TPO membrane base flashing installed over counterflashing

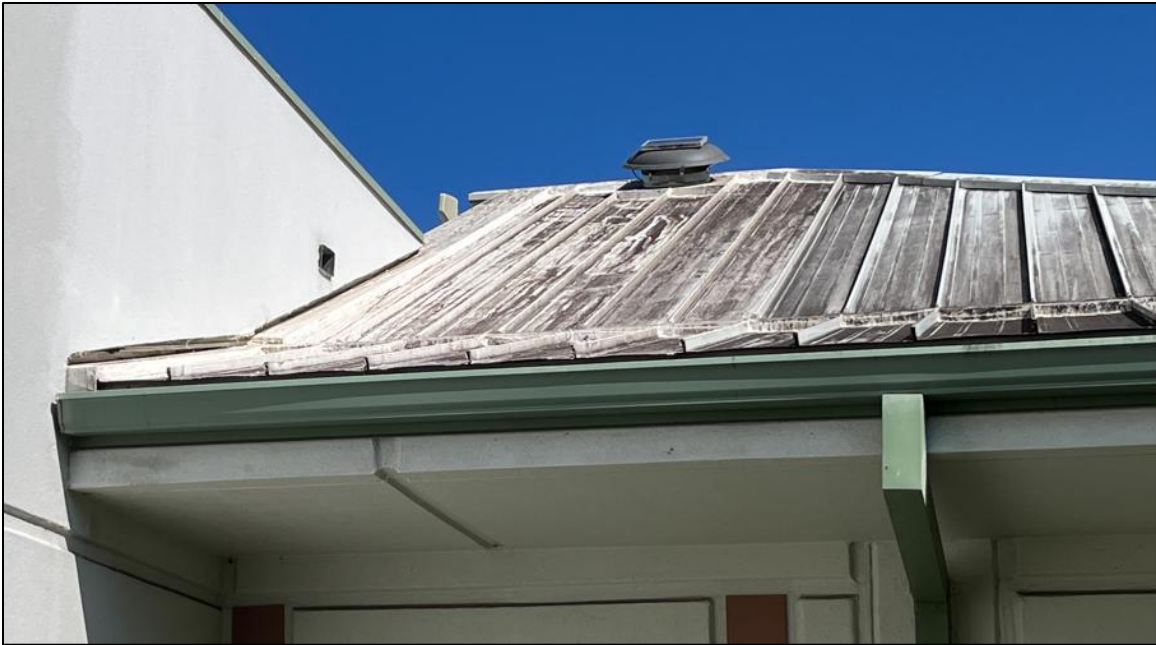
Photo 6 - Coating repairs at south elevation with improper detailing at roof sidewall flashing

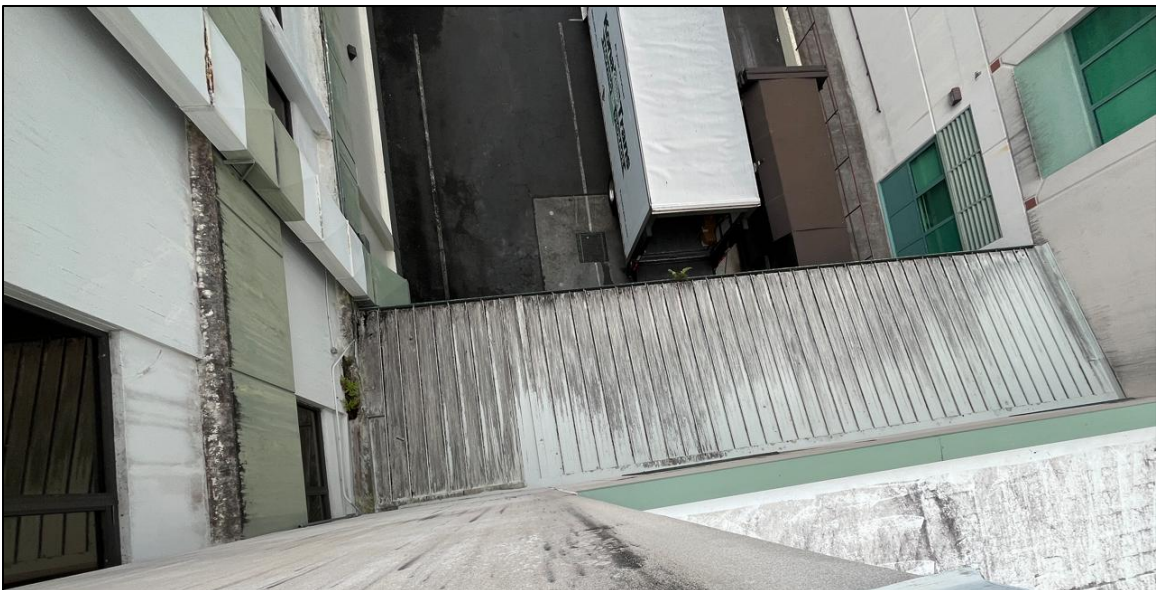
Photo 7 - Standing seam roof over loading dock area at west elevation

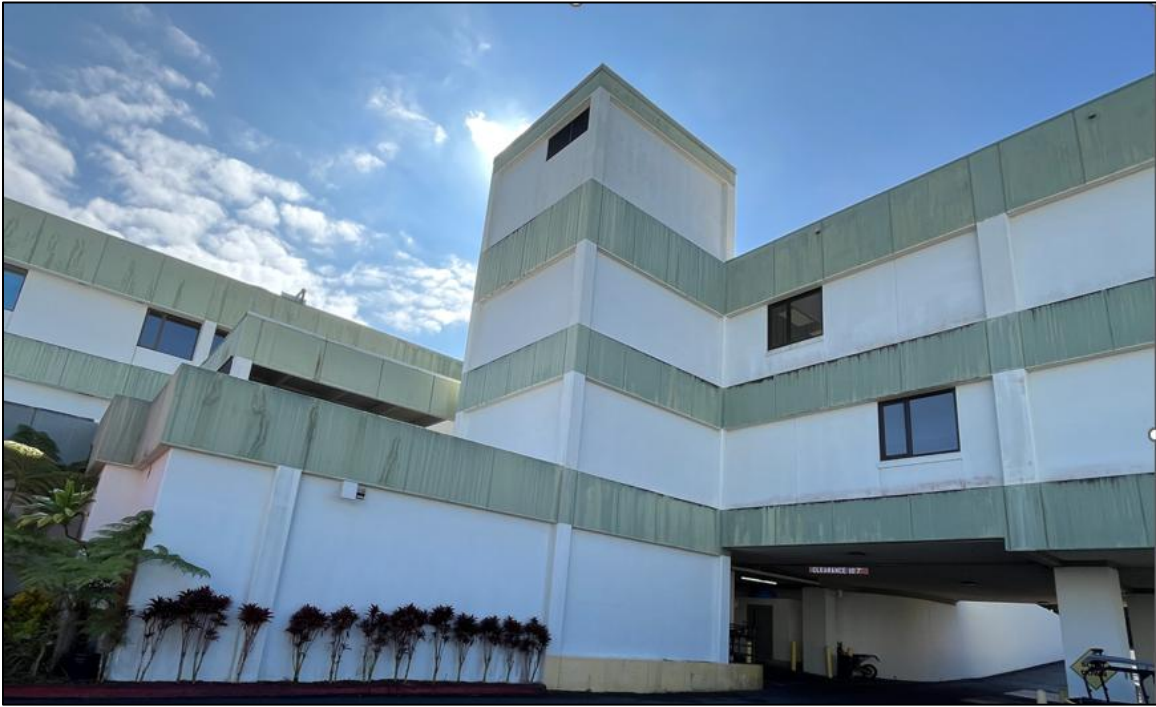
Photo 8 - Overview of Building 1 concrete walls typical condition

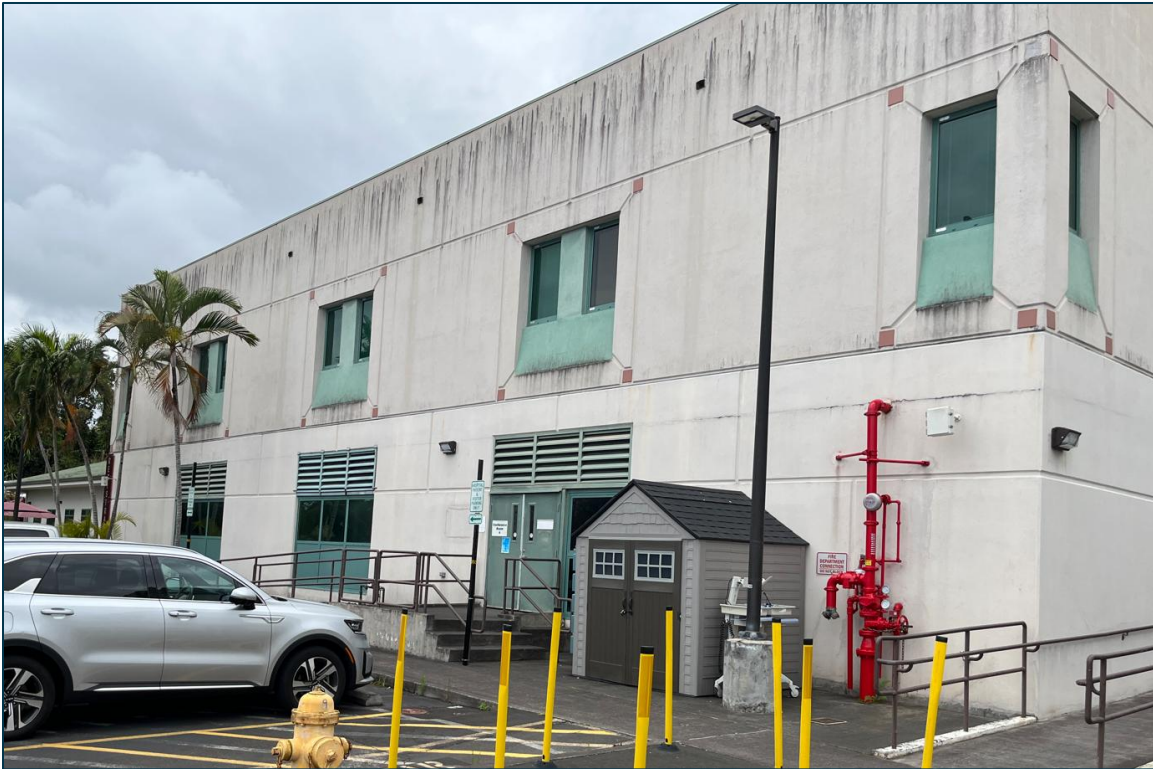
Photo 9 - Overview of Building 1 1998 addition typical exterior wall with EIFS cladding (West Elevation)

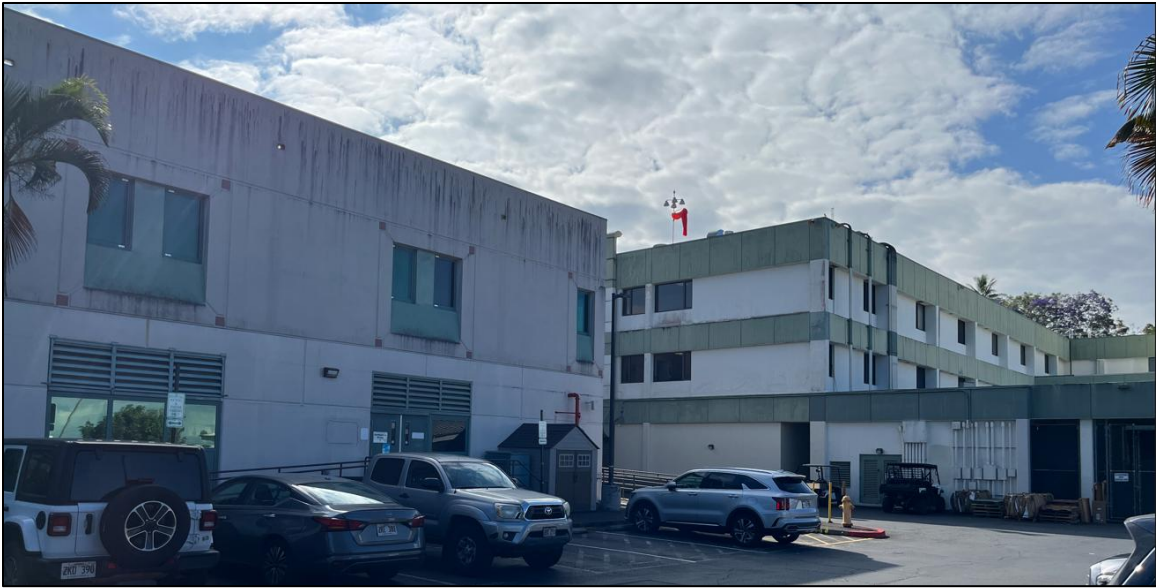
Photo 10 - Overview of Building 1 exterior walls and windows facing southeast

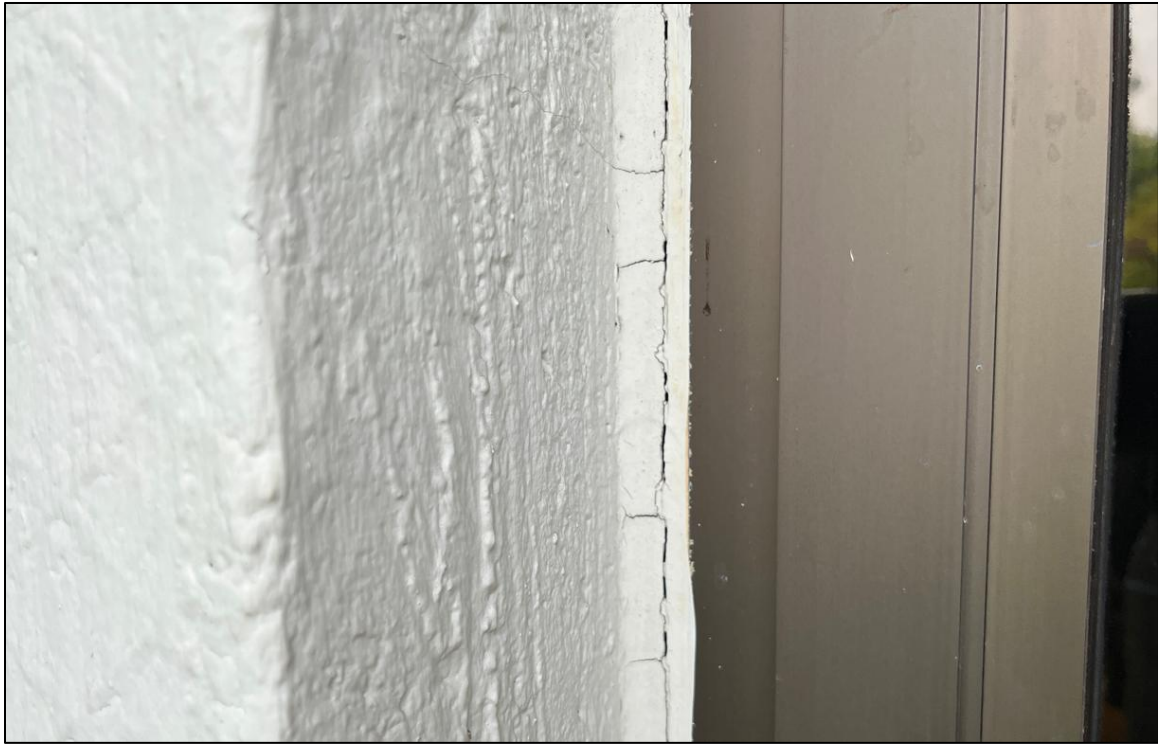
Photo 12 - Typical cracked paint finish applied over window perimeter joints

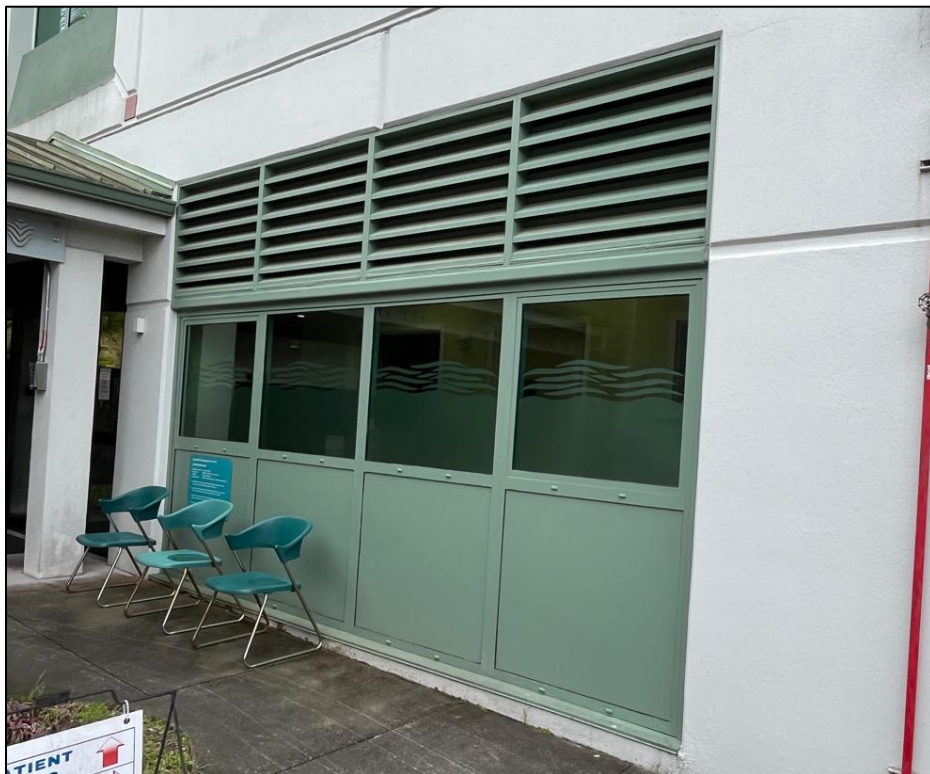
Photo 13 - Painted aluminum framed windows and painted steel louvers at Building 1 1989 Addition north elevation adjacent to Building 3.

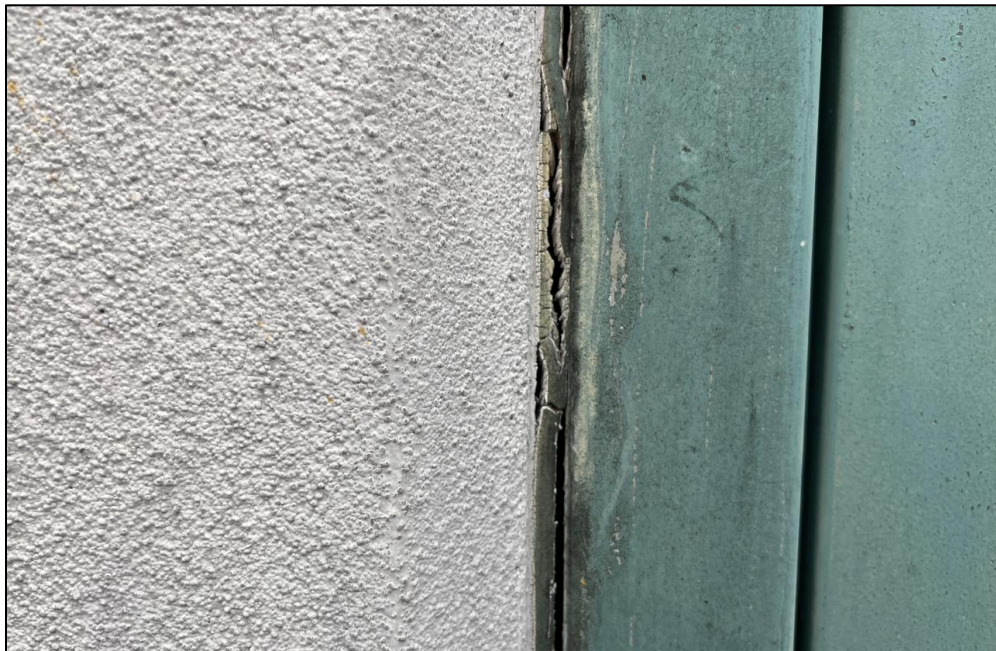
Photo 15 - Failing sealant joint between steel door frame and EIFS cladding at the West Elevation of Building 1 -1989 Addition

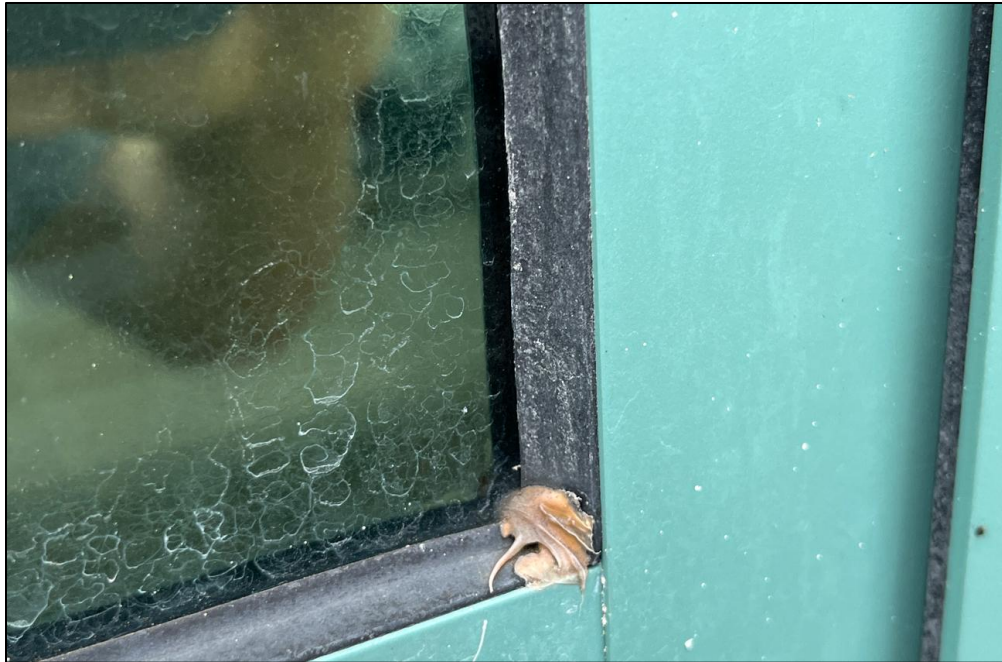
Photo 16 - Sealant repair at window glazing gasket noted at Building 1 1989 Addition West Elevation

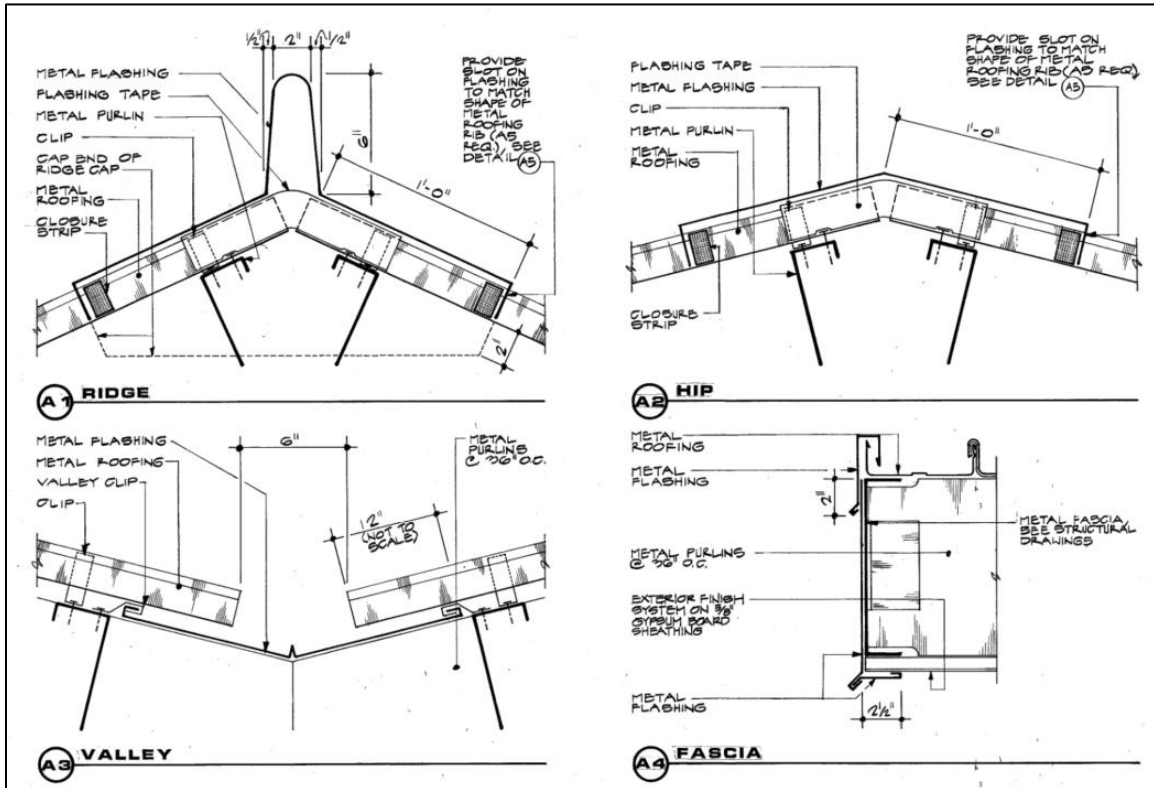
Figure 3 - Roof details from Building 2 1996 record drawings

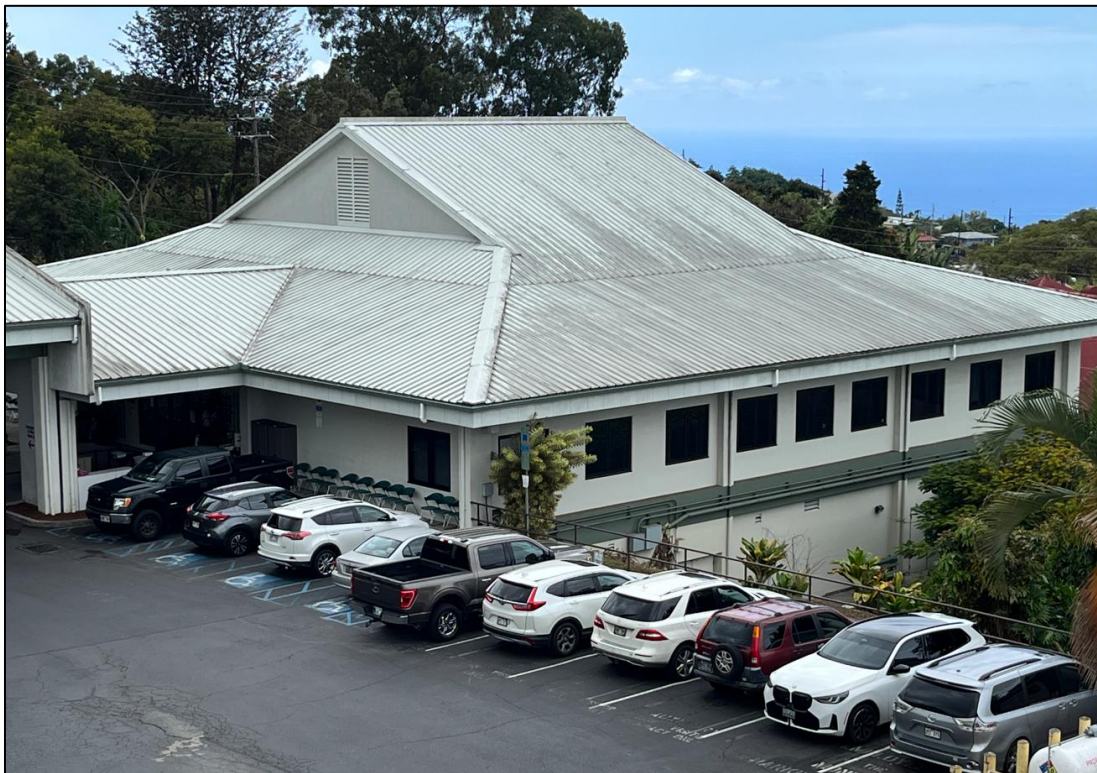
Photo 18 - Overview of standing seam metal roof at Building 2 (facing south)

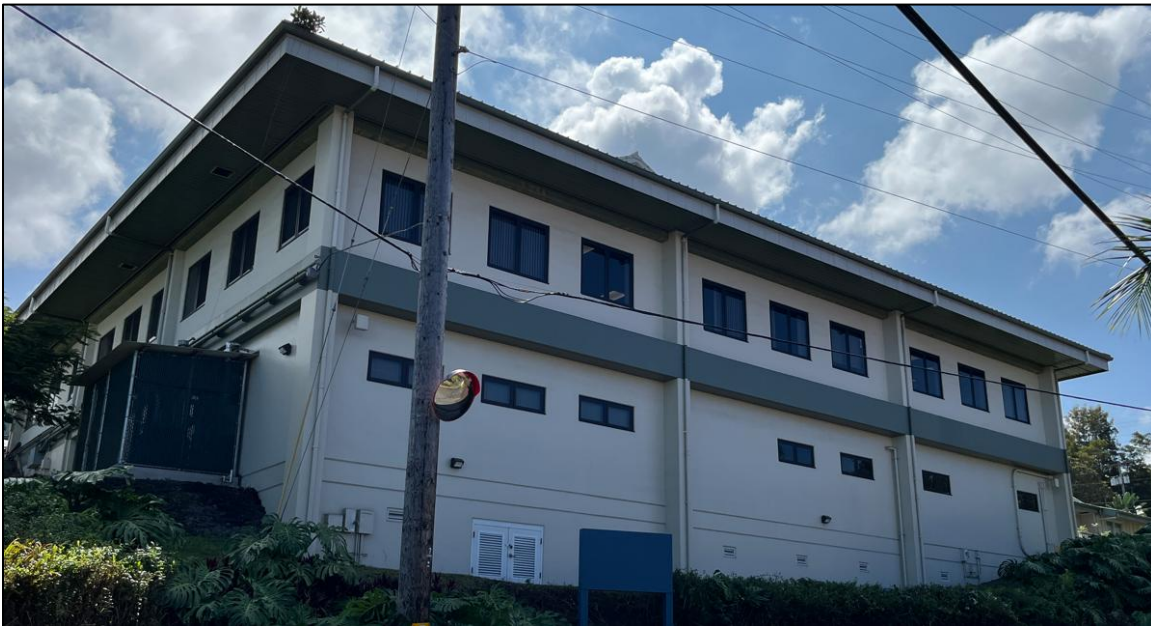
Photo 19 - Overview of Building 2 west elevation

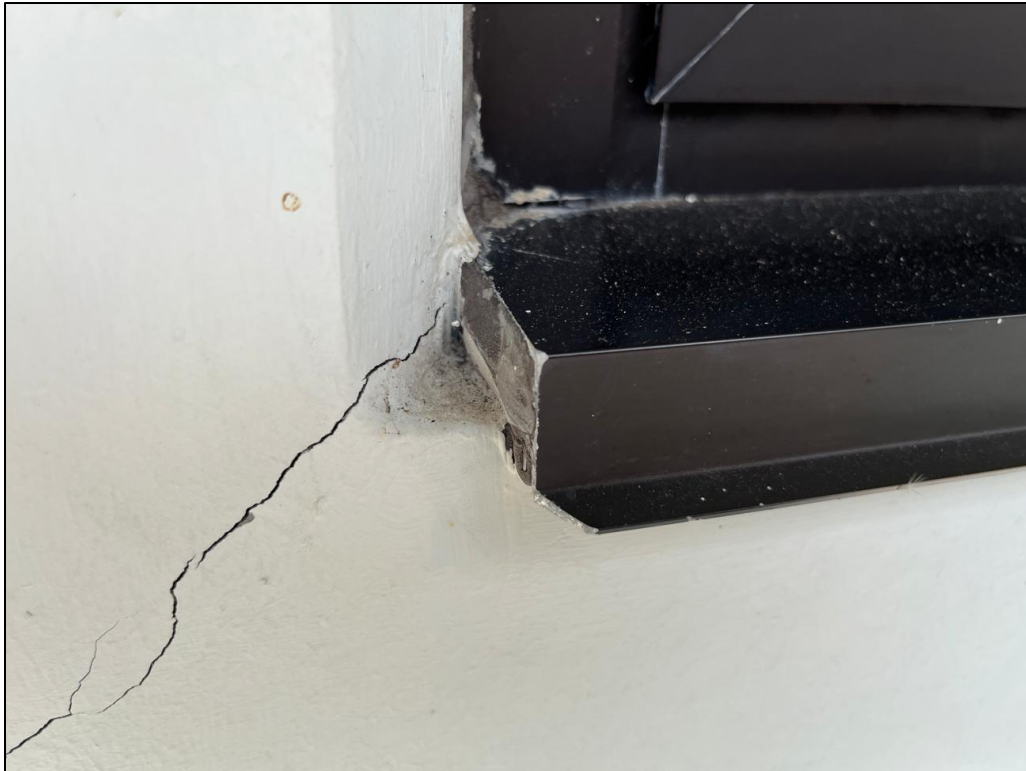
Photo 21 - Cracked concrete at window at east elevation of Building 2

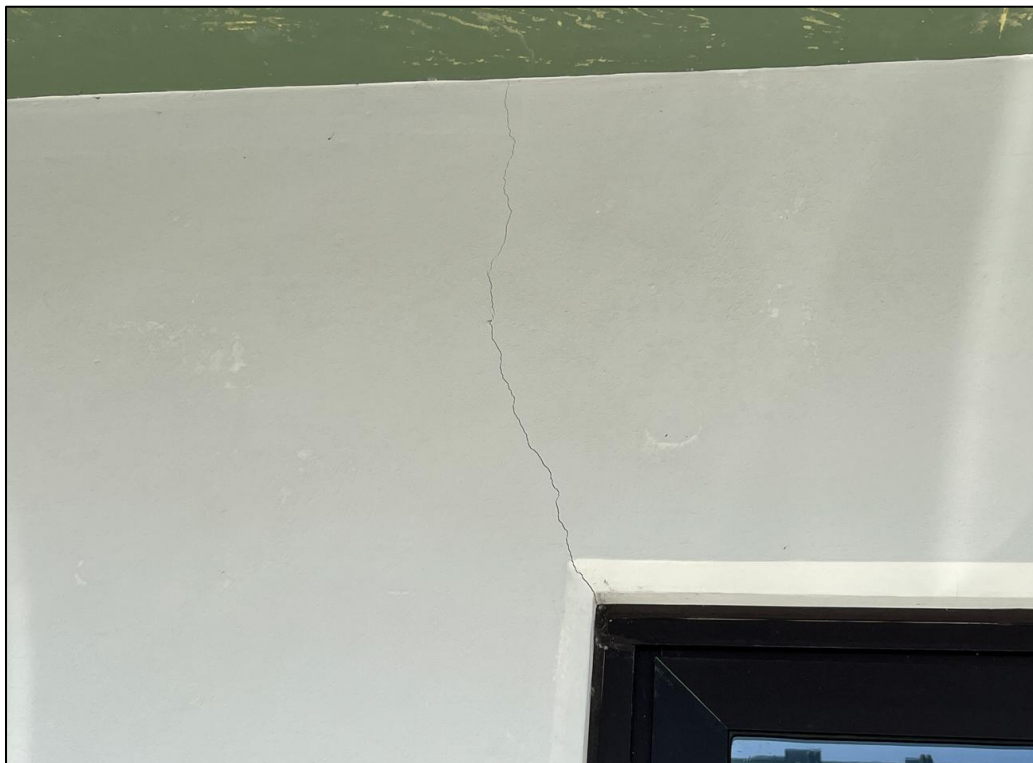
Photo 22 - Cracked concrete at window at east elevation of Building 2

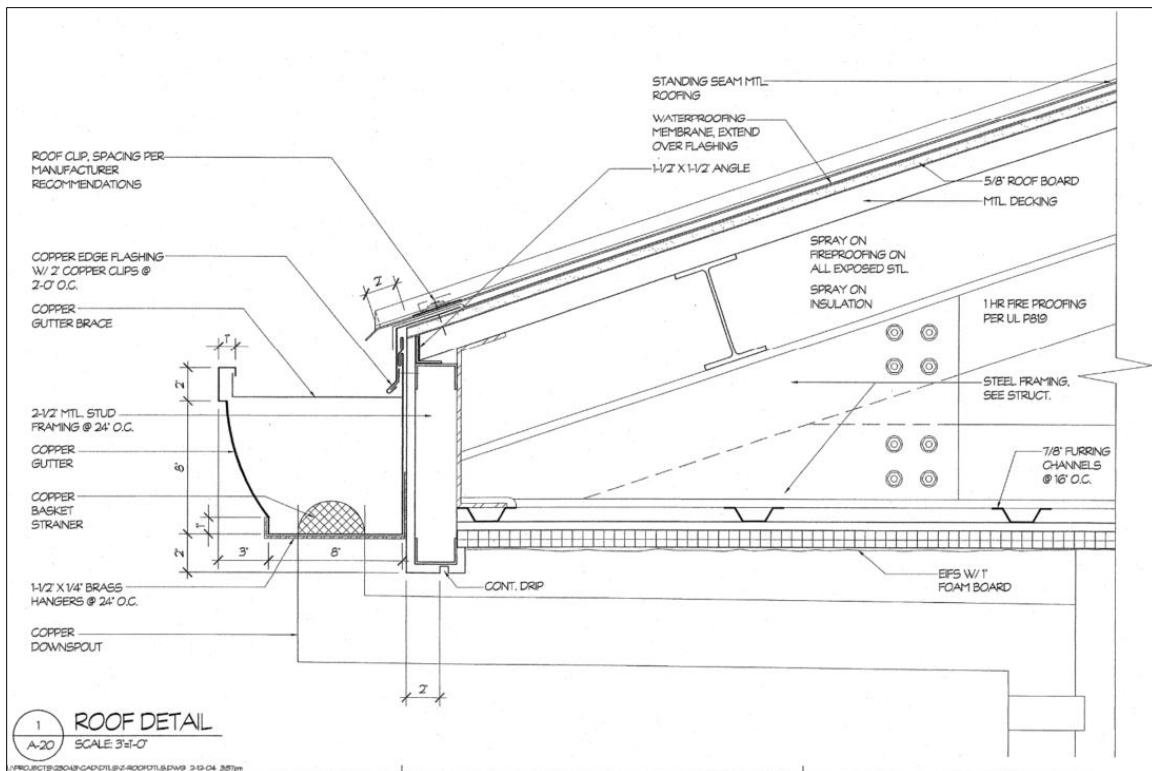
Figure 5 - Roof detail from 1998 Building 3 record drawings

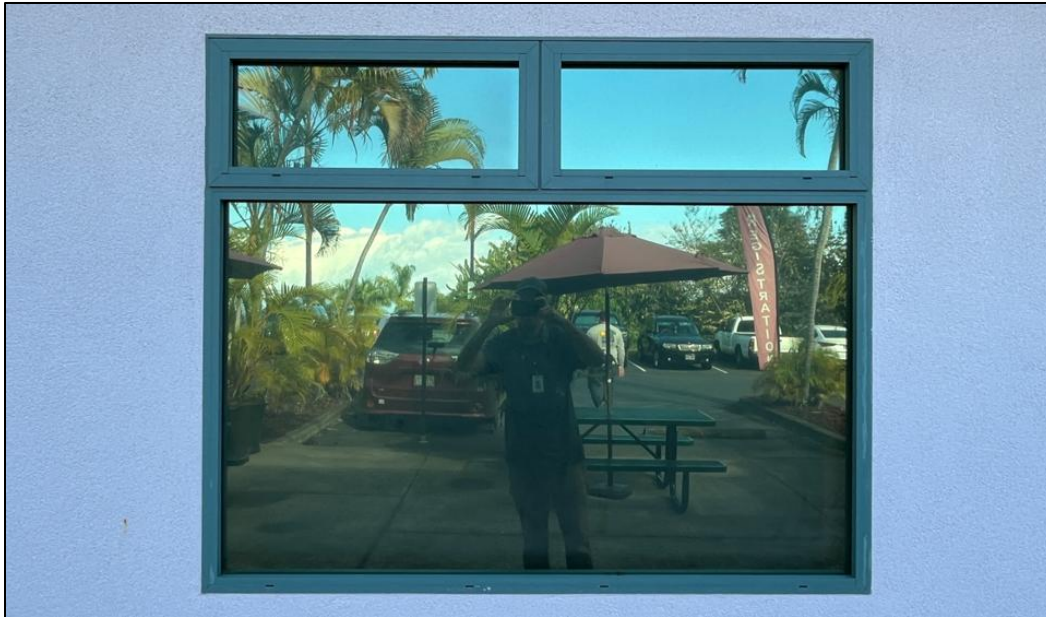
Photo 25 - Typical painted aluminum block frame window at Building 3

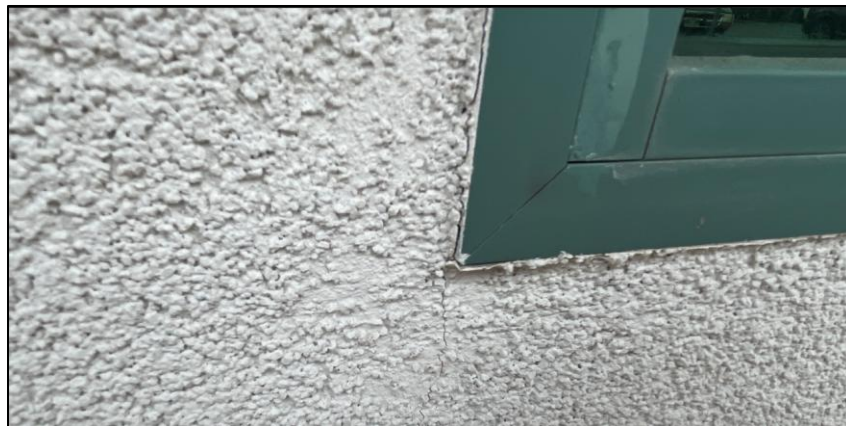
Photo 26 - Typical detailing at window and EIFS cladding. No sealant joint observed at window perimeters. Note touch up paint.

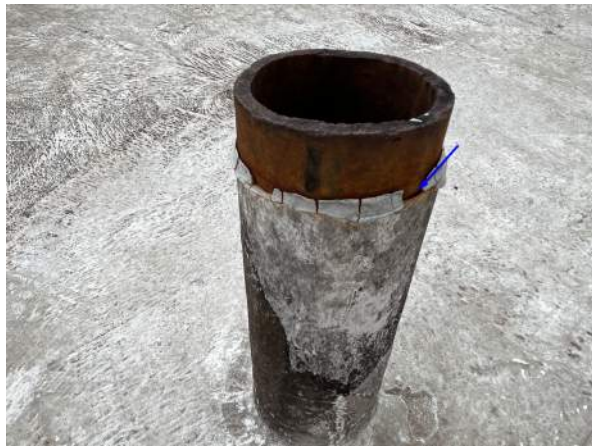
- 6 - IMPROPER DETAILING AT STEEP SLOPE ROOF SIDE WALL FLASHING AT EIFS CLAD EXTERIOR WALL.

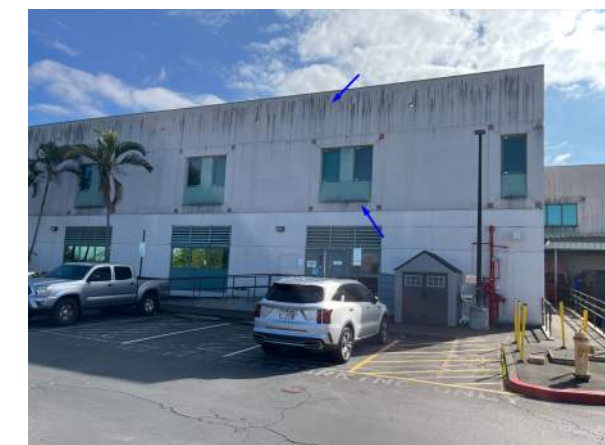
OBSERVATION NUMBERS:
 7 - WORN AND FADED EXTERIOR WALL PAINT FINISH (TYP.).
 8 - DISBONDED BUBBLING PAINT FINISH.
 9 - CRACKED AND DISBONDED CEMENT PLASTER FINISH.
 10 - IMPROPER FLASHING AT EIFS WALL TERMINATION.
 11 - STAINED EIFS FINISH FROM DIRT BUILD UP (TYP.).
 12 - LATERAL CRACKING AT EIFS FINISH.

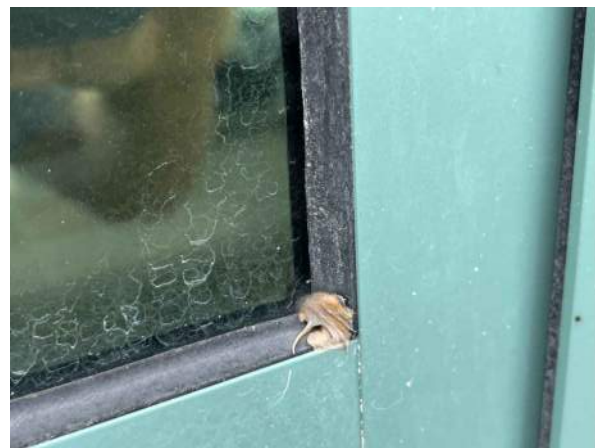
- OBSERVATION NUMBERS:**
- 13 - TYPICAL ANODIZED ALUMINUM BLOCK FRAME WINDOW
 - 14 - CRACKED PAINT OVER SEALANT JOINT
 - 15 - STEEL CORROSION AT LOUVER FRAME
 - 16 - SEALANT JOINT FAILURE
 - 17 - WINDOW GASKET REPAIR
 - 18 - SEALANT JOINT FAILURE
